Number	N.4
Section	Body and Exhaust System
Sheet	1 (of 1)
Date	May, 1960

Number N.6
Section Body & Exhaust System

Number N.7
Section Body

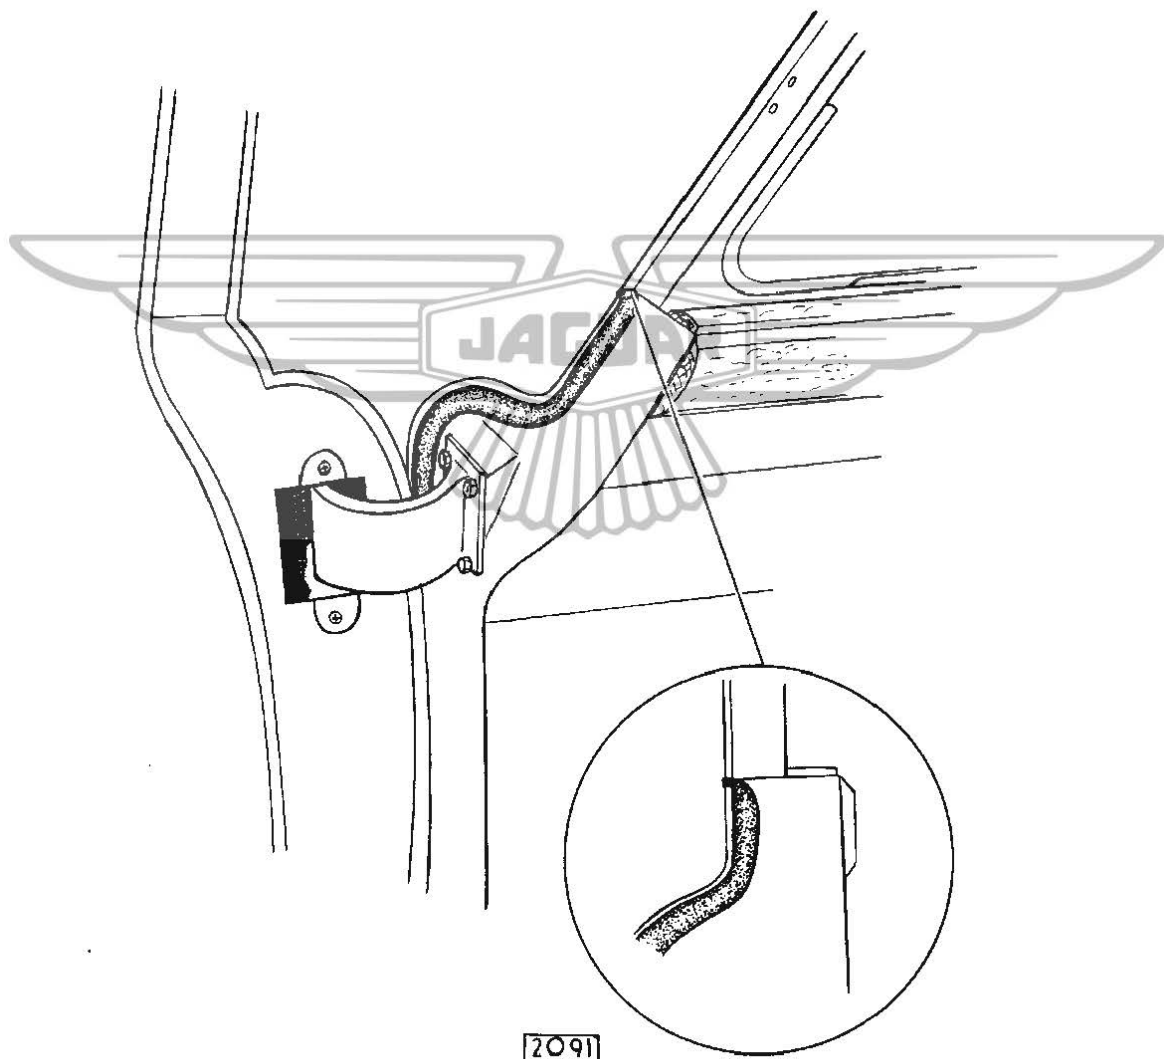
WIND NOISE

In cases of complaint of wind noise from the front edges of the front doors on Mark 2 models, it is recommended that a rubber sealing strip is fitted to the forward edge of the doors adjacent to the top hinge.

To fit the strip (Part Number BD.21361 (L.H.), BD.21362 (R.H.)) remove the front door capping and waist rail and pull the top of the door trim casing away from below the window aperture. Slacken the two screws below the no draught ventilator and pull the frame away from the door. Using a suitable adhesive, stick the sealing strip to the forward edge of the door so that the upper end is trapped by the no draught ventilator frame (see illustration overleaf). Tighten the securing screws, restick the door casing trim and refit the waist rail and door capping.

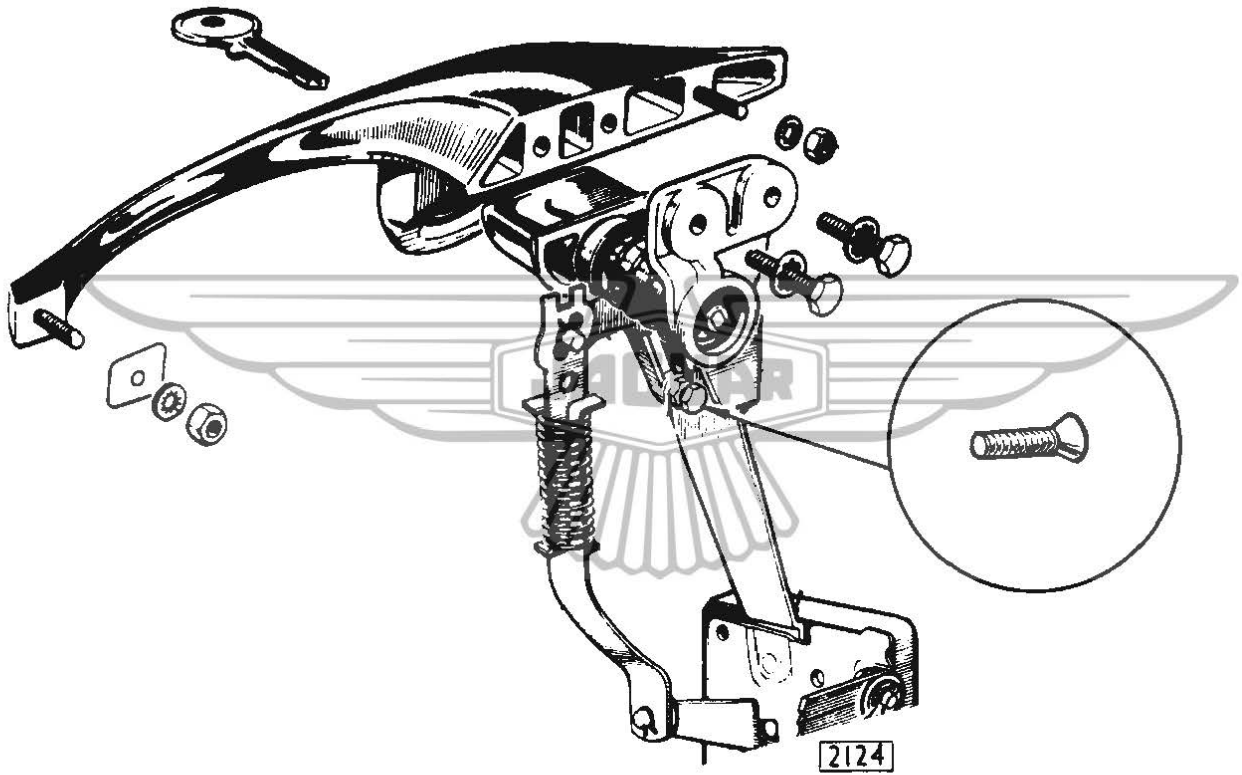
DOOR LOCK MODIFICATION

If trouble is experienced with the door locks jamming when the outside button and inside lever are operated at the same time, the following modification should be carried out.

Remove the door casing, wood capping and plastic covering as described in Section N "Body and Exhaust System" of the Mark 2 Service Manual. Move the inner door handle into the locked position. This action moves the plunger operating lever from behind the lock contactor. Slacken the lock nut and unscrew the push button plunger bolt (shown in the illustration overleaf). Discard the hexagon headed bolt and screw the locknut onto the countersunk cross-headed screw (Part Number 8949). Screw the countersunk screw into the plunger operating lever. The clearance between the head of the plunger screw and the lock contactor should be $\frac{1}{32}$ " (0.8 mm). To adjust, slacken the locknut, screw the plunger screw in or out as required and retighten the locknut.

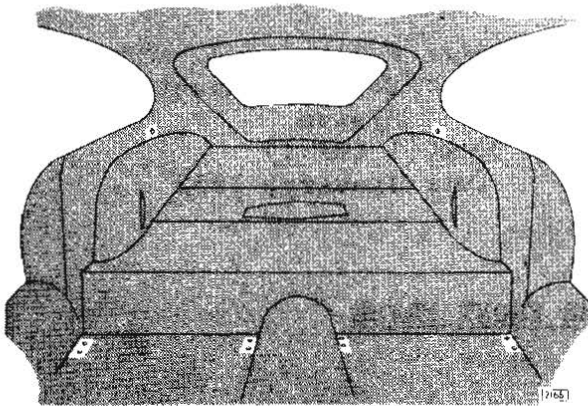
'E' TYPE FIXED HEAD COUPE

On cars with the above chassis numbers and onwards, mounting points for the attachment of seat belt anchor brackets are provided. The mounting points are in the positions shown overleaf and are designed to suit a wide range of seat belt types. The pairs of holes for floor mountings are $2\frac{1}{2}$ " (6.35 cm) between centres, one hole being a $\frac{3}{8}$ " (9.5 mm) plain clearance hole and the other being a $7/16$ " (11.1 mm) UNF tapped hole. The mountings holes behind the seats or on the centre pillars are all tapped $7/16$ " (11.1 mm) UNF. (See illustrations overleaf).

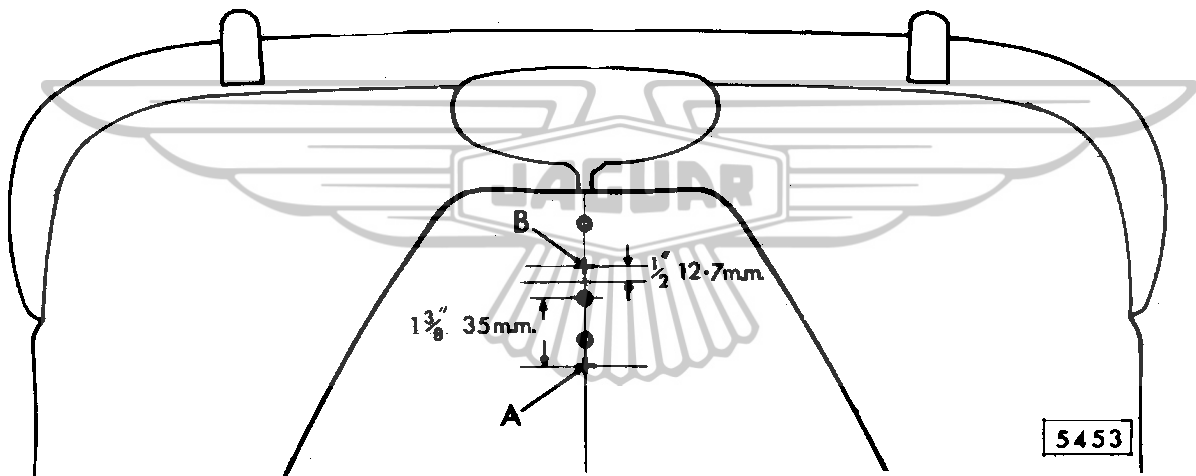
Difficulties in manufacturing Bonnet Mascot BD.10954 have resulted in it being withdrawn and supplies are no longer available. Orders for replacements for the above cars will therefore be executed by Jaguar Spares Division supplying an alternative Bonnet Mascot BD.29644 which varies from the original by the positions of the mounting studs. Instructions for the installation of the new Mascot are therefore detailed below.

If the original Bonnet Mascot, part number BD.10954, is replaced by Mascot part number BD.29644, the following instructions should be carefully followed:-

1. Remove original Mascot from bonnet
2. Remove front and rear portion of bonnet centre beading
3. Retouch paintwork (if necessary) where bonnet is affected by contact with Mascot or chrome beading.
4. Lightly mark centre line through existing fixing holes, extending line forward by 2 in. (50 mm.).
5. Drill 3/16 in. (4.8 mm.) hole 'A' on centre line, 1 3/8 in. (35 mm.) to rear of front Mascot fixing hole. Locate new Mascot in holes
6. Place rear chrome bead in position, mark against rear of new Mascot base. Remove chrome bead and carefully cut to length. Clean up end of bead.
7. Place front chrome bead in position, mark against front of new Mascot base. Remove chrome bead and carefully cut to length. Clean up end of bead.

8. Lightly mark bonnet across front of new Mascot base.
9. Remove Mascot and centre pop bonnet $\frac{1}{2}$ in. (12.7 mm.) forward of mark. Drill $\frac{1}{8}$ in. (3.17 mm.) diameter hole 'B' in bonnet.
10. Locate clip BD.11719 and secure to bonnet, using pop rivet BD.1814/6
11. Fit Mascot and secure to bonnet, using special cup washer, part number 1744 at front fixing, nuts UCN.119/2 and shake-proof washers C.723/A
12. Fit modified front and rear chrome beads.

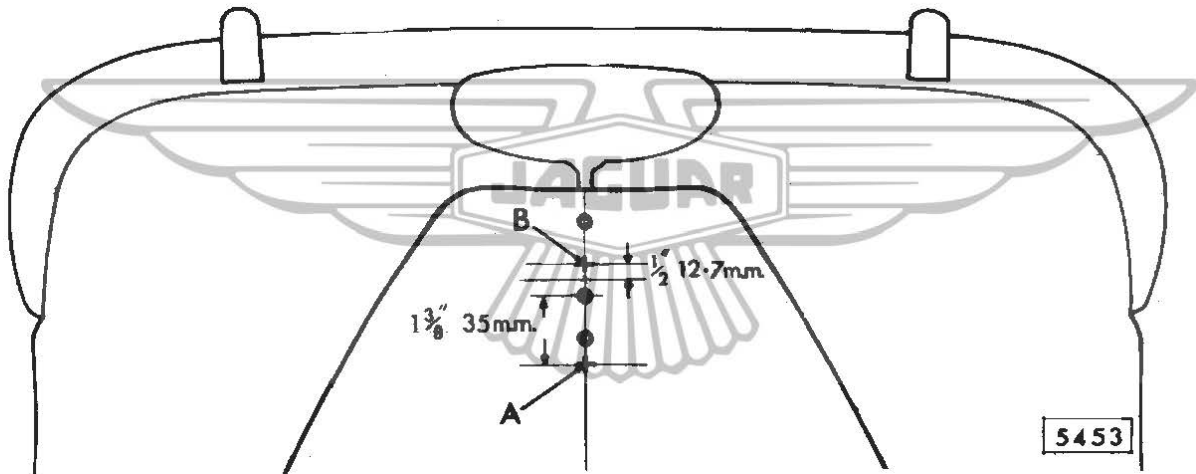
Difficulties in manufacturing Bonnet Mascot BD.10954 have resulted in it being withdrawn and supplies are no longer available. Orders for replacements for the above cars will therefore be executed by Jaguar Spares Division supplying an alternative Bonnet Mascot BD.29644 which varies from the original by the positions of the mounting studs. Instructions for the installation of the new Mascot are therefore detailed below.

If the original Bonnet Mascot, part number BD.10954, is replaced by Mascot part number BD.29644, the following instructions should be carefully followed:-

1. Remove original Mascot from bonnet
2. Remove front and rear portion of bonnet centre beading
3. Retouch paintwork (if necessary) where bonnet is affected by contact with Mascot or chrome beading.
4. Lightly mark centre line through existing fixing holes, extending line forward by 2 in. (50 mm.).
5. Drill 3/16 in. (4.8 mm.) hole 'A' on centre line, 1 3/8 in. (35 mm.) to rear of front Mascot fixing hole. Locate new Mascot in holes
6. Place rear chrome bead in position, mark against rear of new Mascot base. Remove chrome bead and carefully cut to length. Clean up end of bead.
7. Place front chrome bead in position, mark against front of new Mascot base. Remove chrome bead and carefully cut to length. Clean up end of bead.

8. Lightly mark bonnet across front of new Mascot base.
9. Remove Mascot and centre pop bonnet $\frac{1}{2}$ in. (12.7 mm.) forward of mark. Drill $\frac{1}{8}$ in. (3.17 mm.) diameter hole 'B' in bonnet.
10. Locate clip BD.11719 and secure to bonnet, using pop rivet BD.1814/6
11. Fit Mascot and secure to bonnet, using special cup washer, part number 1744 at front fixing, nuts UCN.119/2 and shake-proof washers C.723/A
12. Fit modified front and rear chrome beads.

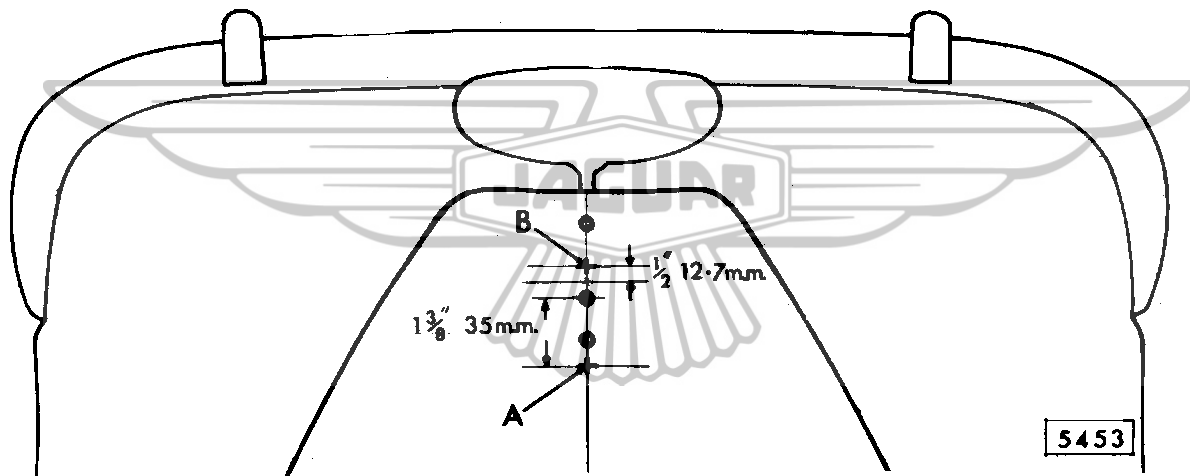
Difficulties in manufacturing Bonnet Mascot BD.10954 have resulted in it being withdrawn and supplies are no longer available. Orders for replacements for the above cars will therefore be executed by Jaguar Spares Division supplying an alternative Bonnet Mascot BD.29644 which varies from the original by the positions of the mounting studs. Instructions for the installation of the new Mascot are therefore detailed below.

If the original Bonnet Mascot, part number BD.10954, is replaced by Mascot part number BD.29644, the following instructions should be carefully followed:-

1. Remove original Mascot from bonnet
2. Remove front and rear portion of bonnet centre beading
3. Retouch paintwork (if necessary) where bonnet is affected by contact with Mascot or chrome beading.
4. Lightly mark centre line through existing fixing holes, extending line forward by 2 in. (50 mm.).
5. Drill 3/16 in. (4.8 mm.) hole 'A' on centre line, 1 3/8 in. (35 mm.) to rear of front Mascot fixing hole. Locate new Mascot in holes
6. Place rear chrome bead in position, mark against rear of new Mascot base. Remove chrome bead and carefully cut to length. Clean up end of bead.
7. Place front chrome bead in position, mark against front of new Mascot base. Remove chrome bead and carefully cut to length. Clean up end of bead.

8. Lightly mark bonnet across front of new Mascot base.
9. Remove Mascot and centre pop bonnet $\frac{1}{2}$ in. (12.7 mm.) forward of mark. Drill $\frac{1}{8}$ in. (3.17 mm.) diameter hole 'B' in bonnet.
10. Locate clip BD.11719 and secure to bonnet, using pop rivet BD.1814/6
11. Fit Mascot and secure to bonnet, using special cup washer, part number 1744 at front fixing, nuts UCN.119/2 and shake-proof washers C.723/A
12. Fit modified front and rear chrome beads.
